**Flood Control Project Maintenance
Levee Inspections**

Fall 2014 Levee Maintenance Deficiency Summary Report

Sacramento River Basin

Sutter Maintenance Yard East Levee Sacramento River

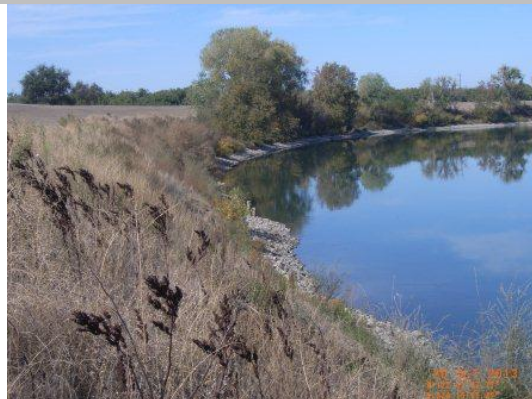
Photo 1 of 1 : FA_2014_ST0003_264_27_20141013_00012.jpg

LM Start	0.00	Rating **	M	Issue No.	27
LM End	11.41	Issue Type +	Ma	Location *	WS
Category	Supplemental			GPS Latitude/Longitude	
				Start	End
Item	USACE Erosion Survey			39.266315 °	39.265730 °
				-122.020682 °	-122.014925 °
DWR ID	DWR_ST0003_01_f_2014_27				
Action/Comments					
Inspector Comments: 2009 - Slump in the middle of the section has left a vertical section on the bank. 2010 - Old cobble site unraveling, site extended downstream. 2013: No observed changes. [2013 Site ID: SAC_151-0_R]

USACE 2013 Photo #1

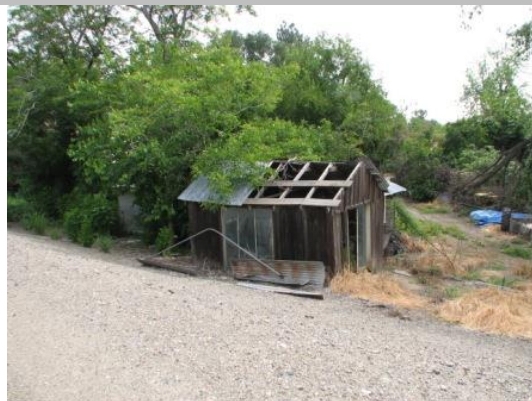
Photo 1 of 1 : FA_2014_ST0003_264_3_20141013_00002.jpg

LM Start	0.08	Rating **	U	Issue No.	3
LM End	0.14	Issue Type +	En	Location *	WS
Category	Earthen Levee			GPS Latitude/Longitude	
				Start	End
Item	Encroachments			39.194978 °	39.195022 °
				-121.937502 °	-121.938563 °
DWR ID	DWR_ST0003_01_s_2012_3				
Action/Comments					
Building

View of a old building next to the landside toe.

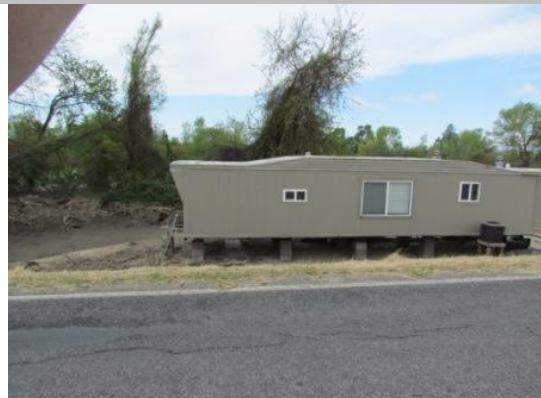
Photo 1 of 1 : FA_2014_ST0003_264_11_20141013_00004.jpg

Action/Comments					
Building

View of the trailer next to the W/S toe.

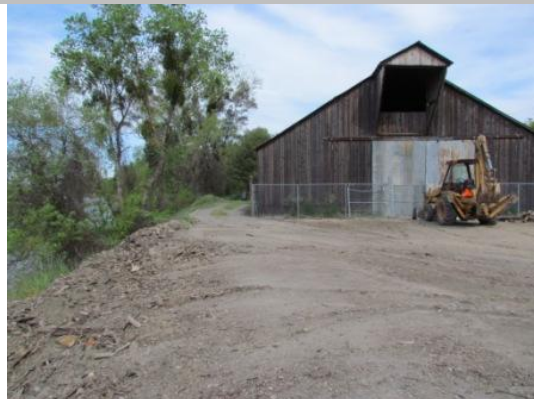
Photo 1 of 1 : FA_2014_ST0003_264_12_20141013_00005.jpg

LM Start	4.66	Rating **	U	Issue No.	12
LM End	4.84	Issue Type +	En	Location *	CR
Category	Earthen Levee			GPS Latitude/Longitude	
				Start	End
Item	Encroachments			39.213265 °	39.213265 °
				-121.991672 °	-121.991672 °
DWR ID	DWR_ST0003_01_s_2012_12				
Action/Comments					
Building

View of the barn on the large crown of the levee.

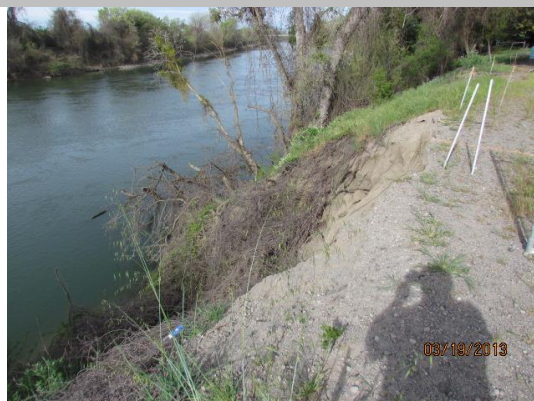
Photo 1 of 1 : FA_2014_ST0003_264_15_20141013_00006.jpg

LM Start	4.66	Rating **	M	Issue No.	15
LM End	4.66	Issue Type +	Ma	Location *	WS
Category	Earthen Levee			GPS Latitude/Longitude	
				Start	End
Item	Slope Stability			39.213271 °	39.213271 °
				-121.991676 °	-121.991676 °
DWR ID	DWR_ST0003_01_s_2013_15				
Action/Comments					
Repair slope instability.

View of the erosion along the waterside slope.

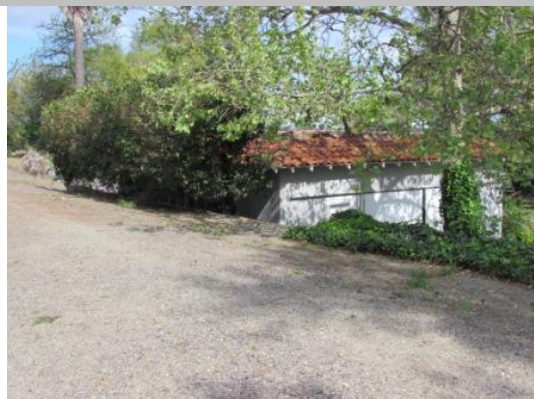
Photo 1 of 1 : FA_2014_ST0003_264_20_20141013_00009.jpg

LM Start	4.81	Rating **	U	Issue No.	20
LM End	4.81	Issue Type +	En	Location *	LS
Category	Earthen Levee			GPS Latitude/Longitude	
				Start	End
Item	Encroachments			39.214168 °	39.214168 °
				-121.993515 °	-121.993515 °
DWR ID	DWR_ST0003_01_s_2012_20				
Action/Comments					
Building

View of the building next to the L/S toe.

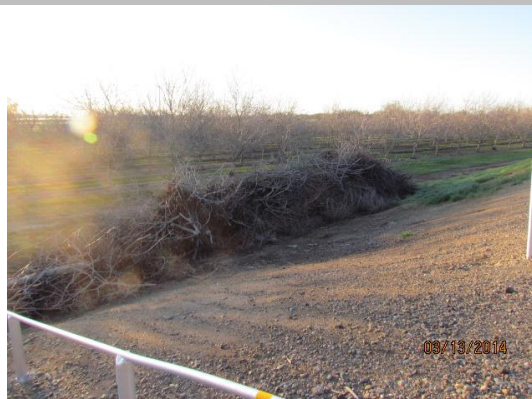
Photo 1 of 1 : FA_2014_ST0003_264_53_20141013_00017.jpg

LM Start	6.34	Rating **	M	Issue No.	53
LM End	6.34	Issue Type +	En	Location *	N/A
Category	Earthen Levee			GPS Latitude/Longitude	
				Start	End
Item	Encroachments			39.223563 °	39.223563 °
				-121.999048 °	-121.999048 °
DWR ID	DWR_ST0003_01_s_2014_53				
Action/Comments					
Prunings

View of the prunings along the landside toe.

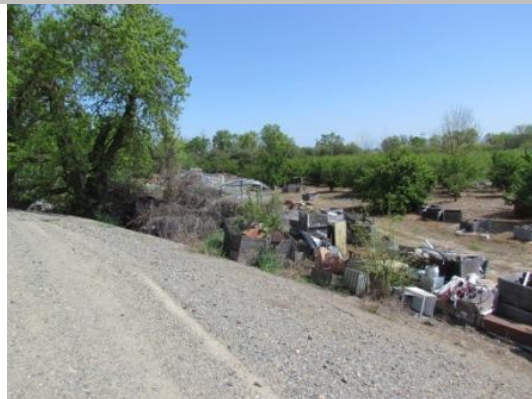
Photo 1 of 1 : FA_2014_ST0003_264_21_20141013_00010.jpg

LM Start	6.42	Rating **	M	Issue No.	21
LM End	6.42	Issue Type +	Ma	Location *	LS
Category	Earthen Levee			GPS Latitude/Longitude	
				Start	End
Item	Encroachments			39.224982 °	39.225013 °
				-121.998600 °	-121.998585 °
DWR ID	DWR_ST0003_01_s_2012_21				
Action/Comments					
Material

View of the material & garbage along the toe.

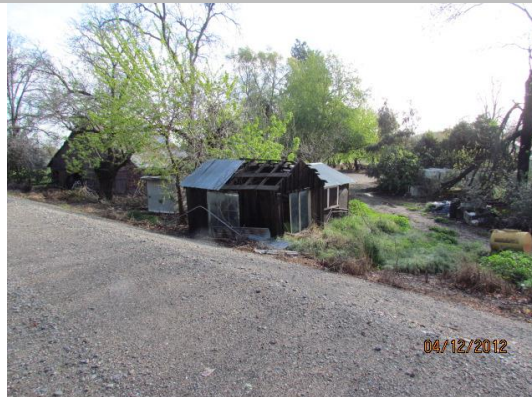
Photo 1 of 1 : FA_2014_ST0003_264_2_20141013_00001.jpg

LM Start	8.76	Rating **	U	Issue No.	2
LM End	8.76	Issue Type +	En	Location *	LS
Category	Earthen Levee			GPS Latitude/Longitude	
				Start	End
Item	Encroachments			39.252260 °	39.252260 °
				-121.997721 °	-121.997721 °
DWR ID	DWR_ST0003_01_s_2012_2				
Action/Comments					
Building

View of the building next to the toe of the levee.

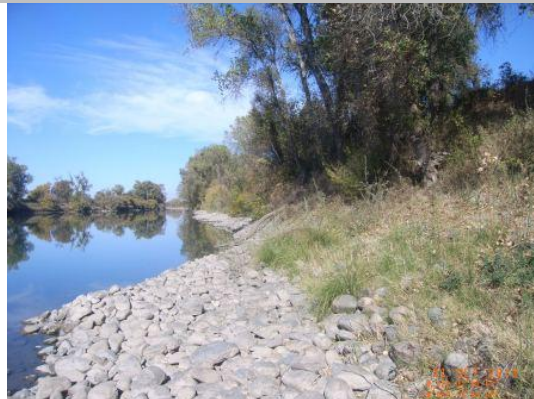
Photo 1 of 1 : FA_2014_ST0003_264_28_20141013_00013.jpg

DWR Start	11.51	Rating **	M	Issue No.	28
LM End	11.51	Issue Type +	Ma	Location *	WS
Category	Supplemental			GPS Latitude/Longitude	
				Start	End
Item	USACE Erosion Survey			39.279910 °	39.283853 °
				-122.018221 °	-122.016113 °
DWR ID	DWR_ST0003_01_f_2014_28				
Action/Comments					
Inspector Comments: 2008 - Large rotational/mass failure in the bank with tree slump. 2009 - Minimal new erosion, the tree is leaning further into the river. 2011 - Site extended downstream. 2012 - Minor new erosion and tree roots are further exposed. 2013: No observed changes. [2013 Site ID: SAC_152-6_L]

USACE 2013 Photo #1

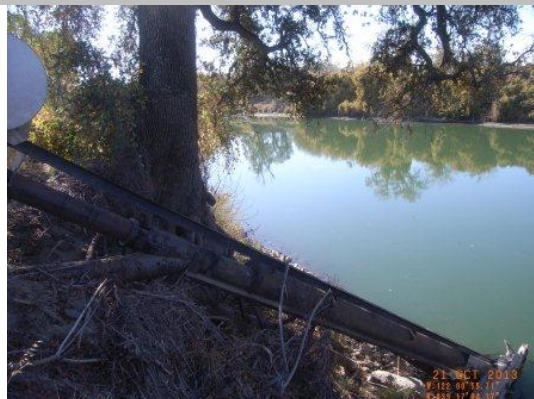
Photo 1 of 1 : FA_2014_ST0003_264_29_20141013_00014.jpg

LM Start	11.83	Rating **	M	Issue No.	29
LM End	11.83	Issue Type +	Ma	Location *	WS
Category	Supplemental			GPS Latitude/Longitude	
				Start	End
Item	USACE Erosion Survey			39.284568 °	39.285298 °
				-122.015690 °	-122.015208 °
DWR ID	DWR_ST0003_01_f_2014_29				
Action/Comments					
Inspector Comments: 2006 - Large rotational/mass failure in the bank with tree slump. Tough clayey toe material. 2007 - Site is between stone revetments with a pump station at the downstream end. 2010 - Erosion is into the levee toe. 2011 - Minor new erosion. 2012 - Minor new erosion. 2013: No observed changes. [2013 Site ID: SAC_152-8_L]

USACE 2013 Photo #1

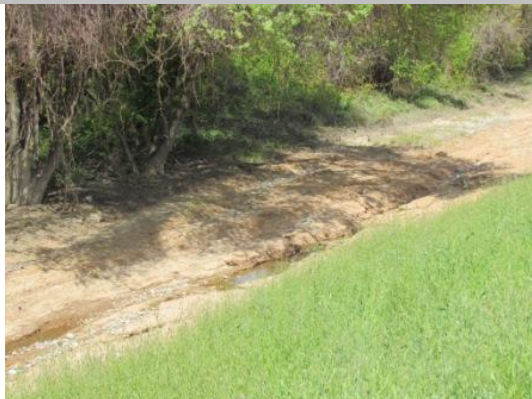
Photo 1 of 1 : FA_2014_ST0003_264_9_20141013_00003.jpg

LM Start	13.47	Rating **	M	Issue No.	9
LM End	13.66	Issue Type +	Ma	Location *	WS
Category	Earthen Levee			GPS Latitude/Longitude	
				Start	End
Item	Erosion / Bank Caving			39.307448 °	39.310231 °
				-122.013037 °	-122.012912 °
DWR ID	DWR_ST0003_01_s _ 2012_9				
Action/Comments					
Note and monitor erosion site.

View of the erosion along the W/S toe.

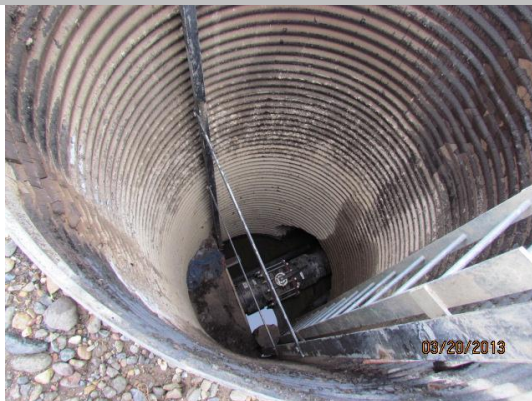
Photo 1 of 1 : FA_2014_ST0003_264_25_20141013_00011.jpg

LM Start	14.55	Rating **	U	Issue No.	25
LM End	14.55	Issue Type +	En	Location *	WS
Category	Earthen Levee			GPS Latitude/Longitude	
				Start	End
Item	Encroachments			39.322254 °	39.322254 °
				-122.015985 °	-122.015985 °
DWR ID	DWR_ST0003_01_s_ 2013_25				
Action/Comments					
Pipe

View of the unauthorized pipe placed inside the drain pipe.

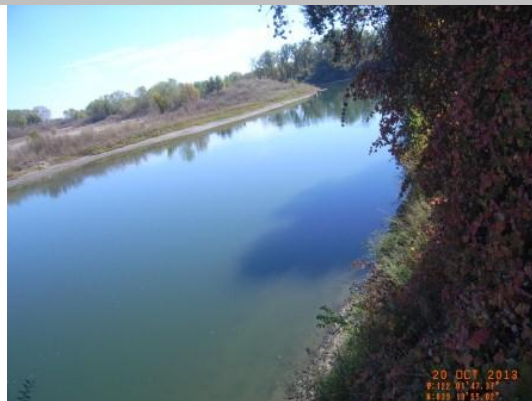
Photo 1 of 1 : FA_2014_ST0003_264_55_20141013_00019.jpg

LM Start	15.53	Rating **	M	Issue No.	55
LM End	15.53	Issue Type +	Ma	Location *	WS
Category	Supplemental			GPS Latitude/Longitude	
				Start	End
Item	USACE Erosion Survey			39.331447 °	39.332716 °
				-122.029440 °	-122.029953 °
DWR ID	DWR_ST0003_01_f_2014_55				
Action/Comments					
Inspector Comments: 2004 - Slowly eroding but near vertical with no vegetation to hold it. 2005 - Erosion is close to levee toe but not into the levee section yet. 2010 - Some new toe scour. 2013: No observed changes. [2013 Site ID: SAC_157-7_R]

USACE 2013 Photo #1

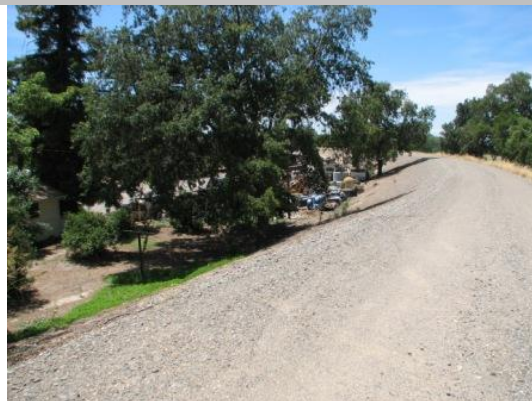
Photo 1 of 1 : FA_2014_ST0003_264_16_20141013_00007.jpg

LM Start	18.04	Rating **	M	Issue No.	16
LM End	18.18	Issue Type +	Ma	Location *	LS
Category	Earthen Levee			GPS Latitude/Longitude	
				Start	End
Item	Encroachments			39.359188 °	39.359980 °
				-122.006878 °	-122.004517 °
DWR ID	DWR_ST0003_01_s_2012_16				
Action/Comments					
Equipment

View of the equipment and trees next to the landside toe of the levee.

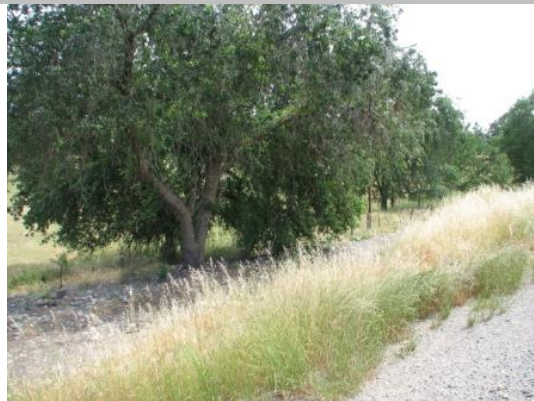
Photo 1 of 1 : FA_2014_ST0003_267_2_20141013_00001.jpg

LM Start	0.02	Rating **	M	Issue No.	2
LM End	0.02	Issue Type +	Ma	Location *	WS
Category	Earthen Levee			GPS Latitude/Longitude	
				Start	End
Item	Vegetation			39.338141 °	39.338141 °
				-122.021852 °	-122.021852 °
DWR ID	DWR_ST0003_04_s_ 2012_2				
Action/Comments					
Elderberries are blocking visibility and flood fight capability.

View of an elderberry bush by the waterside toe.

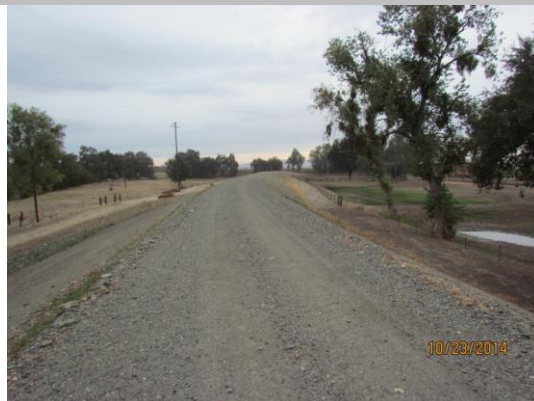
Photo 1 of 1 : FA_2014_ST0003_267_1_20141118_00002.jpg

LM Start	0.11	Rating **	A	Issue No.	1
LM End	0.11	Issue Type +	Ma	Location *	LS
Category	Earthen Levee			GPS Latitude/Longitude	
				Start	End
Item	Vegetation			39.337738 °	39.337738 °
				-122.020207 °	-122.020207 °
DWR ID	DWR_ST0003_04_f _ 2014_1				
Action/Comments					
Control annual grass and weeds on the levee slopes and easements.

View of the levee with controlled vegetation on both slopes.

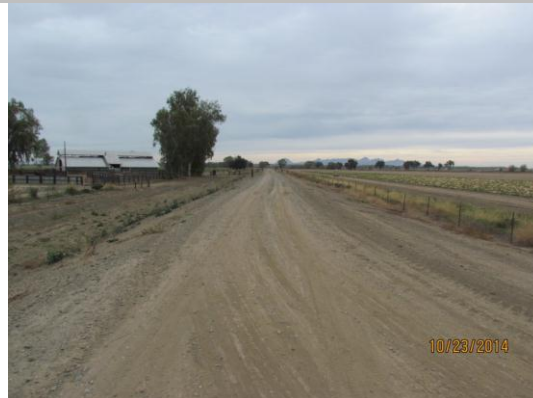
Photo 1 of 1 : FA_2014_ST0003_268_3_20141118_00005.jpg

LM Start	1.10	Rating **	A	Issue No.	3
LM End	1.10	Issue Type +	Ma	Location *	LS
Category	Earthen Levee			GPS Latitude/Longitude	
				Start	End
Item	Vegetation			39.338407 °	39.338407 °
				-122.003972 °	-122.003972 °
DWR ID	DWR_ST0003_05_f_2014_3				
Action/Comments					
Control annual grass and weeds on the levee slopes and easements.

View of controlled vegetation on both slopes.
